Upper Wotton Brook Catchment Study

Part of Lympstone Flood Risk Management Project

Phase 2 Report

May 2019

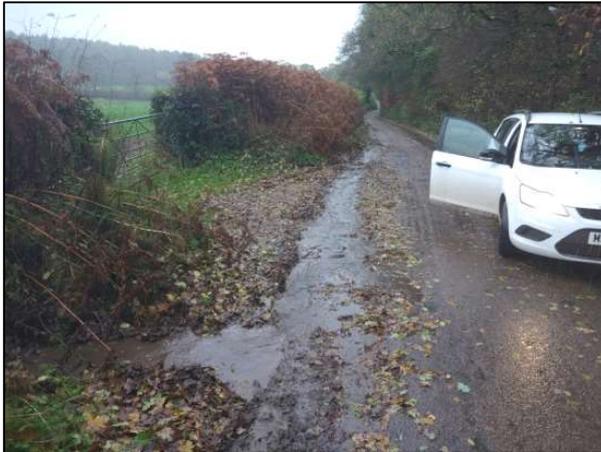
Photo 1 – Run-off along Stoney Lane

Runoff from outside the catchment (Woodbury Common) is partly diverted along Stoney Lane and travels rapidly along the highway to enter the Wotton Brook catchment near the crossroads with Exe View Road.

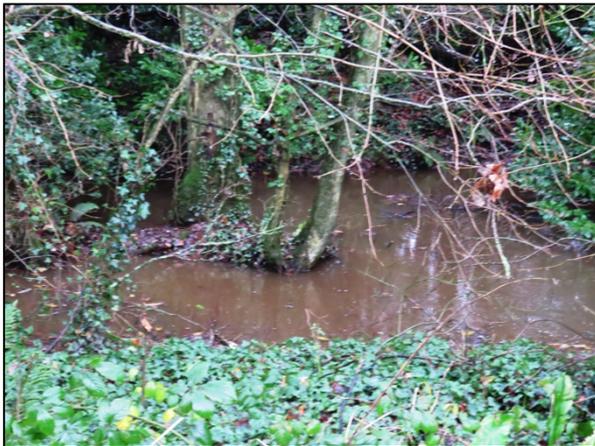
Photo 2 – Goyle containing runoff from Stoney Lane

The surface water runoff flows along Stoney Lane and in roadside ditches before entering a tributary of the Wotton Brook in a wooded goyle near the crossroads with Exe View Road. Some natural flow detention is therefore provided here.

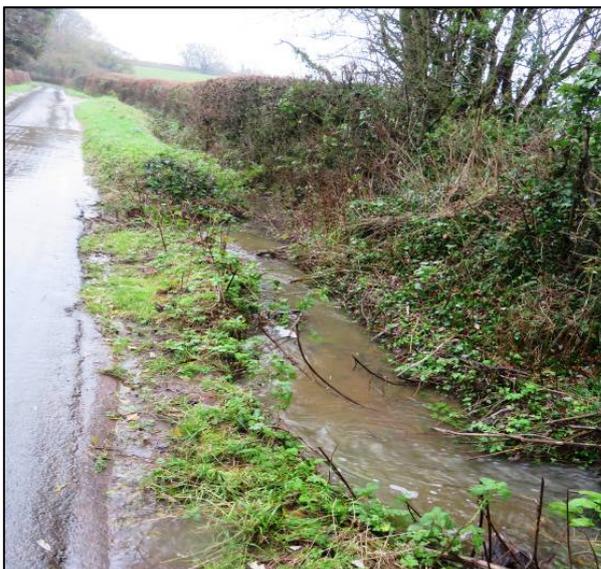
Photo 3 – Runoff entering Exe View Road

The land above the goyle drains southwards to join with overland flows from the solar farm area resulting in periodic flooding of Exe View Road and the adjacent fields north of Coombe Farm. This road was impassable to normal traffic later on 17 December 2018.

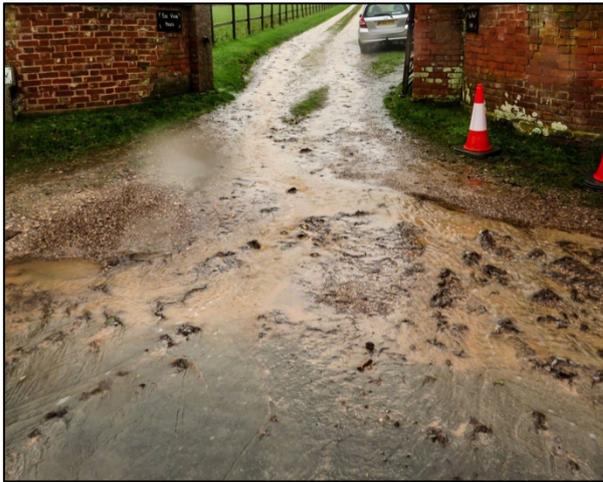
Photo 4 – Drainage from an access track on to Exe View Road

Here surface water from an access track drains towards Exe View Road and combines with flows from the highway. Some then enters a field with post harvest maize stubble.

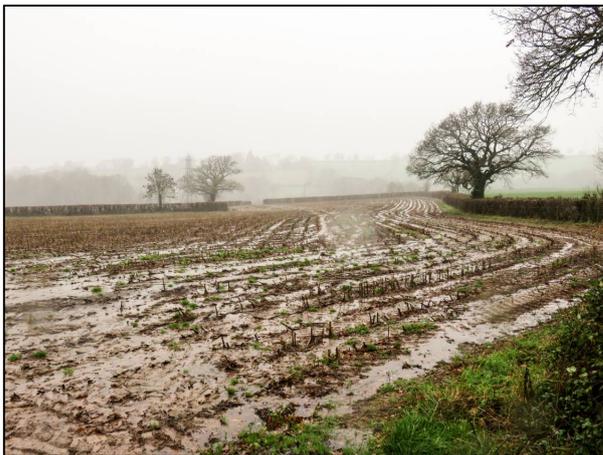
Photo 5 – Ponding and runoff in maize stubble

The ponding of surface water in this post harvest maize field is made worse as a result of surface water runoff from Exe View Road. The photo shows flows draining along the wheelings.

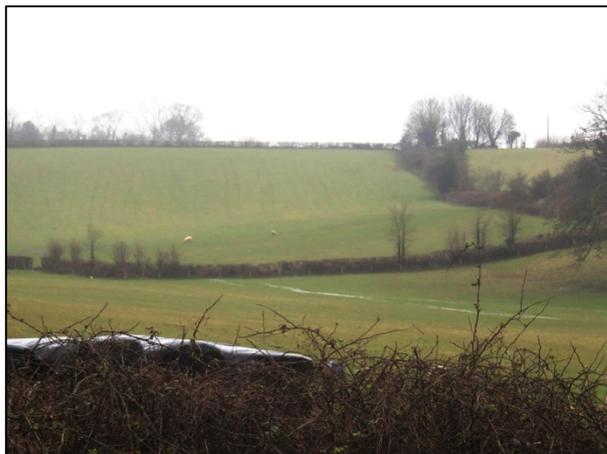
Photo 7 – Runoff over grassland north of Summerfield House

Overland surface water flow results in an intermittent watercourse across the grassland in fields to the north of Summerfield House. This drains to the Brook below Wotton Bridge.

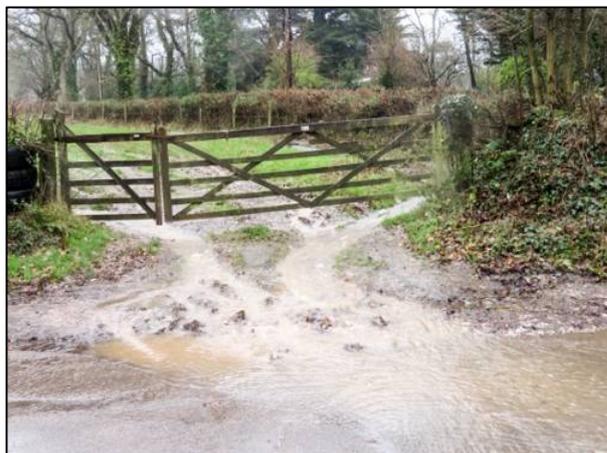
Photo 8 – Runoff from field to Exe View Road

Here a significant flow of surface water leaves the gateway of a grassland field on the corner of Exe View Road. The complex drainage at the intersection of Hulham Road, Exe View Road and Wotton Lane means there is water arriving from several directions.

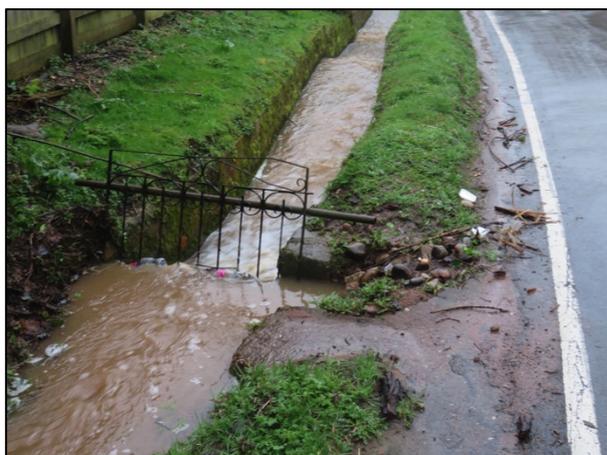
Photo 9 – Roadside ditch on Wotton Lane above Wotton Bridge

Separate streams of surface water, including runoff from Hulham Road, Wotton Lane and various fields, come together in this roadside ditch on Wotton Lane. The ditch often overflows and floods into the highway. Frequent flooding of the external areas of the adjacent property has also been reported.

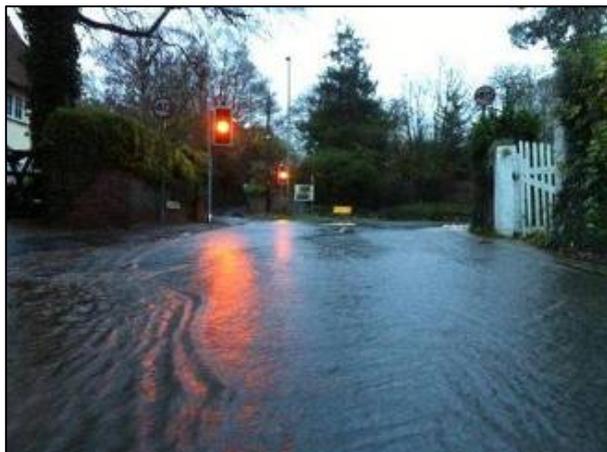
Photo 10 – Flooding on Longmeadow Road

Immediately below the intersection of the A376 and Wotton Lane, Longmeadow Road is reported to flood regularly during heavy and prolonged rainfall events.

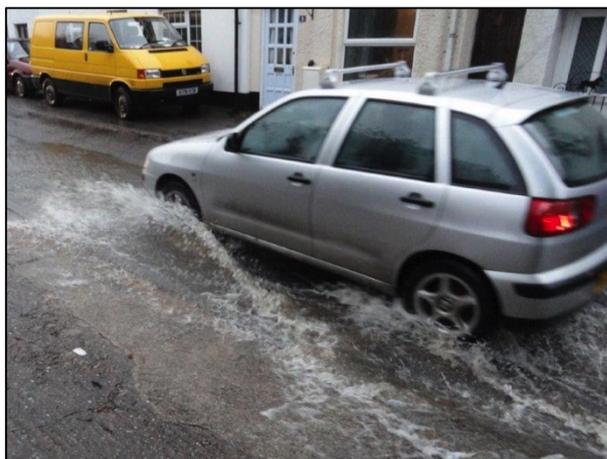
Photo 11 – Surface water lower down Longmeadow Road

It has been reported that vehicles often have to negotiate considerable surface water runoff on the highway.

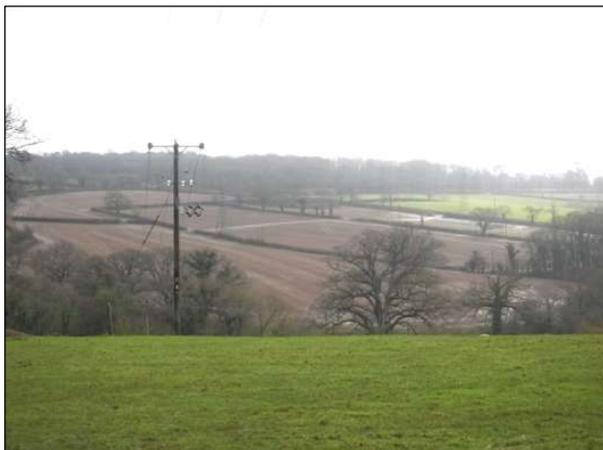
Photo 13 – View showing surface water runoff on maize stubbles

This shows the large areas of exposed soil in post-harvest maize stubbles. The surface water runoff is concentrated in wheelings and natural depressions down the fields towards the Wotton Brook.

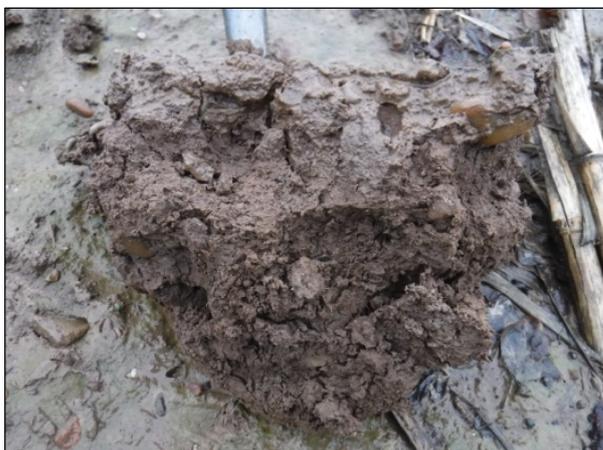
Photo 14 – Example of degraded soil in maize

Soil in the maize headlands and close to gateways (with heavy traffic) is often compacted and has much reduced infiltration. This results in the surface becoming saturated and leads to rapid runoff. The deeper soil is relatively dry and, if the structure had been improved, could have accepted more rainfall before runoff would occur.

Based on our observations during Phase 2 of this study, there is some evidence that degraded soil structure, including capping and compaction, is enhancing surface water runoff in some areas (see Photos 14 and 15 in Section 3.2). However, the full extent of soil structural degradation in the upper catchment is not yet known. This is the purpose of the soil survey to be completed in late 2019 (Phase 3 of the study).

- Avoiding field operations when soils are wet.
- Following the contours during field operations.
- Controlling trafficking to minimise areas of soil damage, e.g., near gateways.
- Using cover crops to protect soils and capture nutrients.
- Avoiding grassland poaching and compaction by stock, or during silage-making.
- Using remedial operations such as sub-soiling (e.g., of arable tramlines) and aeration of degraded grassland soils.
- Using strips of contour ploughing or rough vegetation to reduce runoff.

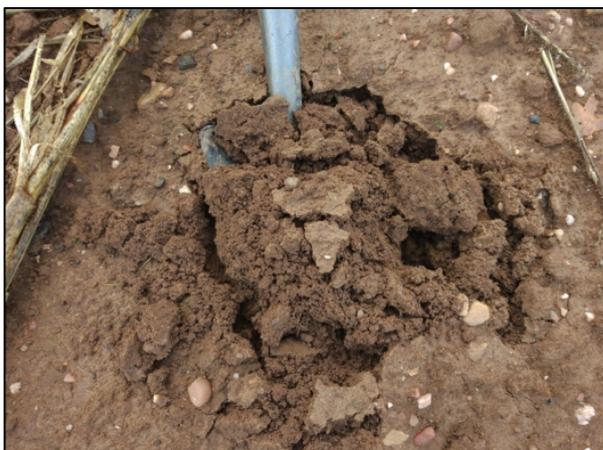
Photo 15 – Soil capping in a maize field

Although this soil shows better sub-surface soil structure, the lack of crop cover has led to some capping of the surface. The soil structure below could easily accept greater quantities of water but the capping will limit the soil's full capability.

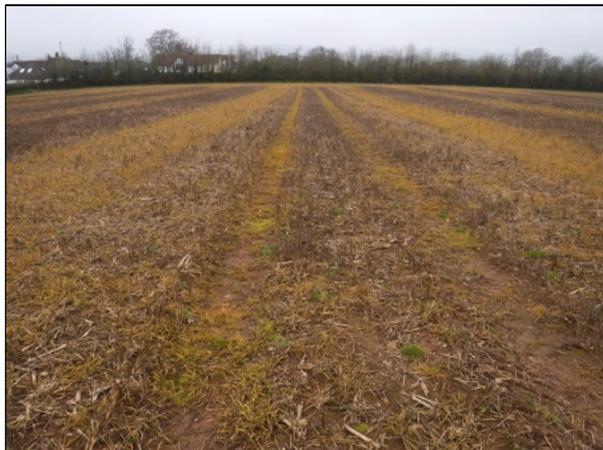
Photo 16 – Tramlines in arable field

The tramlines in this field run down the slope which allows a quicker passage of water to the bottom of the field.

Tramlines are often first created when the soil has higher moisture levels, which leads to compaction. This inhibits water infiltration and the channels increase the speed of overland flow.

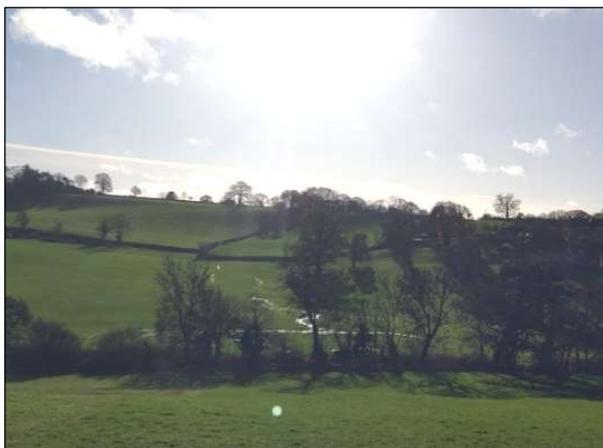
Photo 17 – Runoff across grassland

Looking south east from Tedstone Lane, this indicates significant overland flow below the ridge in a predominantly grassland section of the Wotton Brook catchment. A considerable proportion of the flow emanates from a spring system that sits just below the skyline.

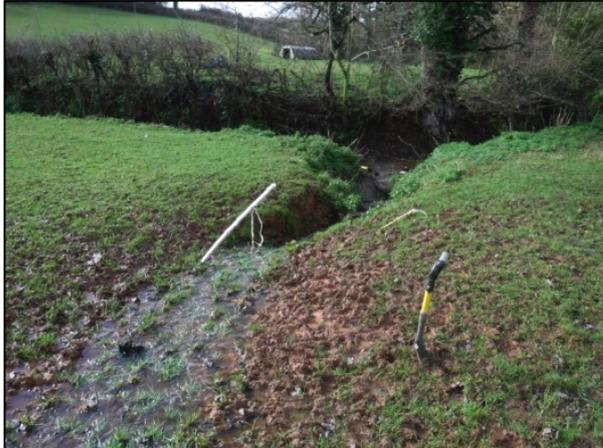
Photo 18 – Runoff from grassland creating a gully

Here runoff from grassland has created a sizable gully where it enters the watercourse. The erosion shown suggests that the overland flow has considerable speed and force at times.

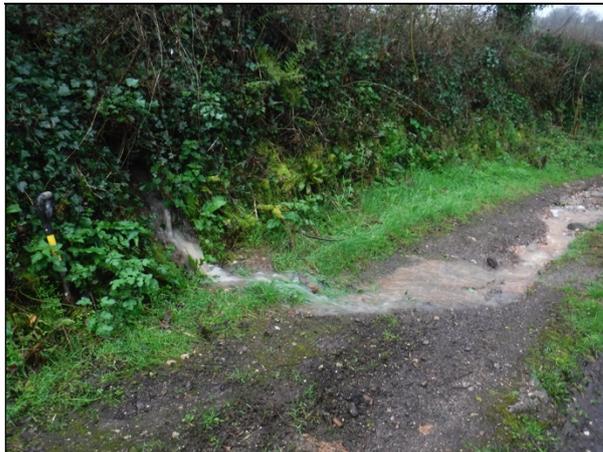
Photo 19 – Runoff from a grass reseeds pouring through the hedge

Runoff from a grass reseed has found its way through a hedge and is using the track as a conduit to the Wotton Brook below.

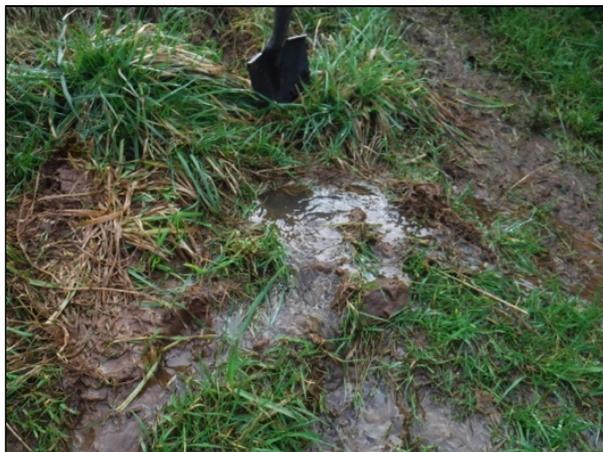
Photo 20 – A spring emanating below the ridge north of Summer Lane

This photo shows one of the springs in the grassland area below the ridge north of Summer Lane. Observations suggest the flows are augmented by runoff from other sources during rainfall events.

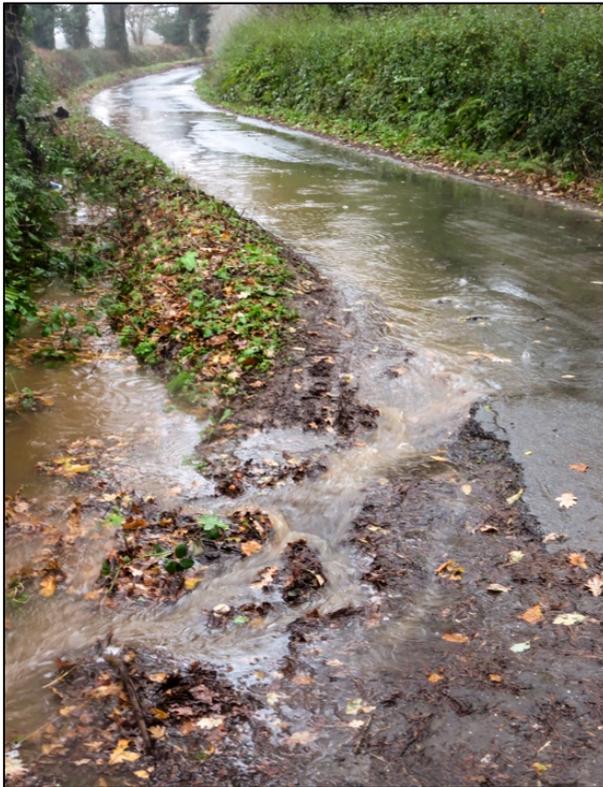
Photo 21 – Overspill from ditches to Exe View Road

The roadside ditches on Exe View Road often fill up and spill onto the road, contributing to highway flooding and the total quantity and rate of runoff. If managed well, the ditches could act as useful temporary storage and help reduce the rate of runoff (see Section 4.3).

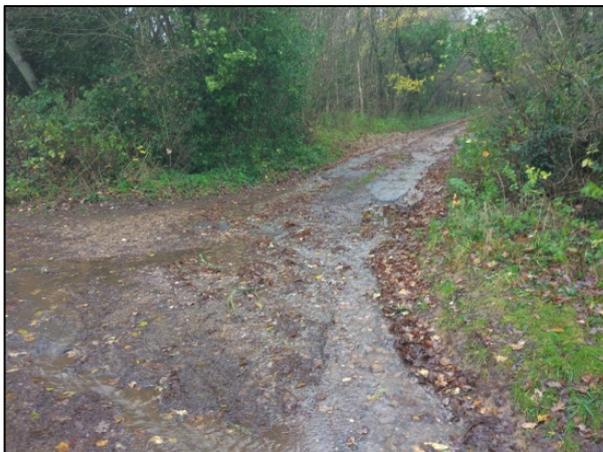
Photo 22 – Run-off from woodland down track

Here drainage from the woodland at the headwaters of the Wotton Brook flows down a track onto Stoney Lane and re-enters the drainage system. It is then thrown out again when flows become too great for the pipe network or become blocked with debris.

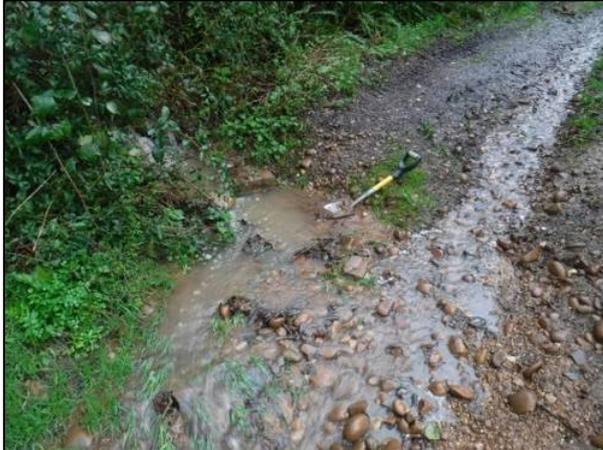
Photo 23 – Runoff from a maize field onto bridleway

The runoff of surface water from an arable field runs through a hedge and takes the easiest route onto a bridleway. This transfers the flow more rapidly down to the Wotton Brook with potential to increase peak flows.

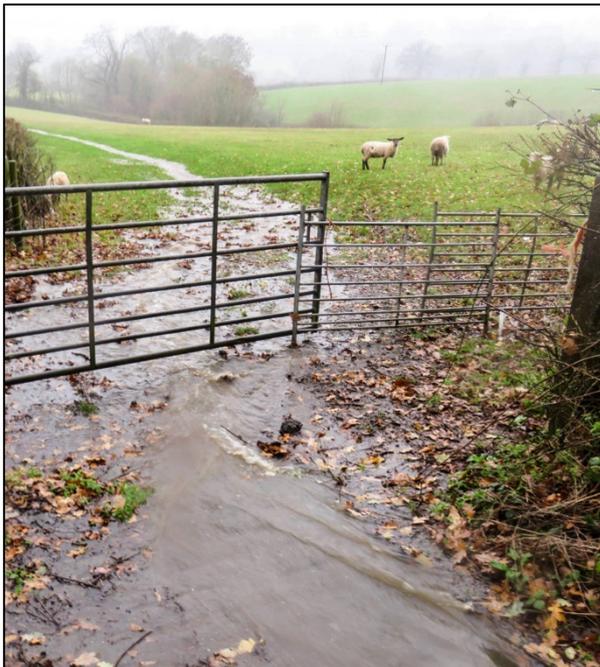
Photo 24 – Runoff from a highway to grassland

This is an example of surface water runoff from a highway (arising from several sources). It follows the slope and is directed into a grass field. If this were an arable field, the impact would be more serious. Nevertheless, it forms an intermittent watercourse and this speeds up the route of the runoff to the Wotton Brook.

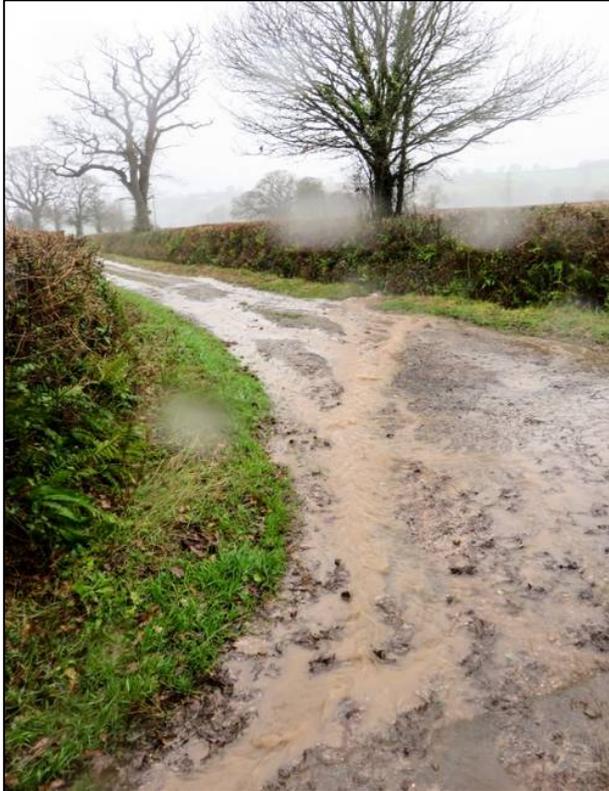
Photo 25 – Highway channelling runoff

This highway is channelling surface water runoff from fields and ditches increasing its rate of flow so that there is potential for more rapid transfer to a watercourse. This is a common theme with the highways providing an unintended acceleration of flows along pathways to the Wotton Brook.

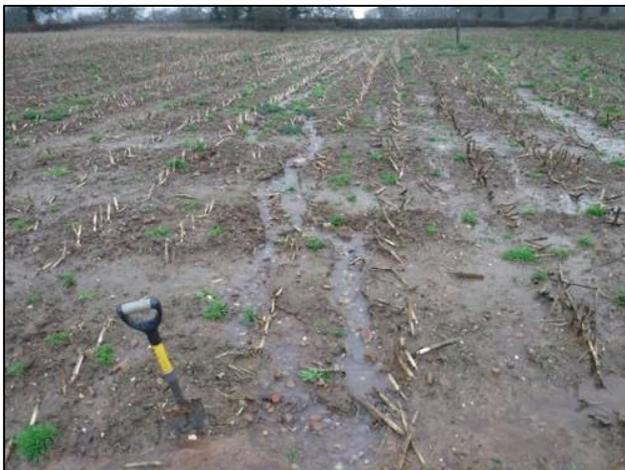
Photo 26 – Track runoff causing impact on arable field

Surface water runoff from a track is diverted into a post-harvest arable maize field. The flow of water cuts rills into the soil giving an ever easier route through the field. Such erosion can also result in severe soil and nutrient loss and pollution of watercourses

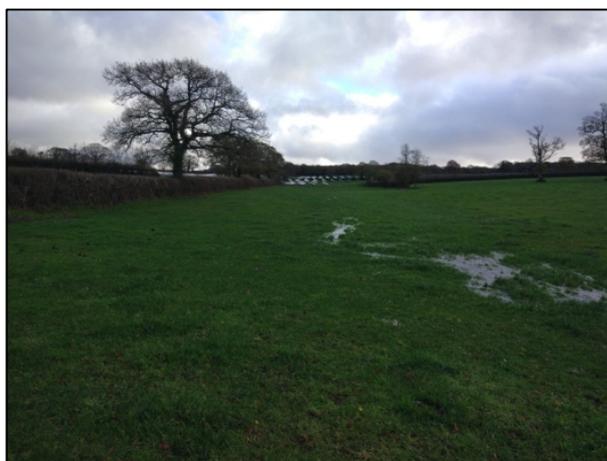
Photo 27 – Surface water on grassland below the solar PV panels

Observations showed a significant volume of water flooding the Exe View Road between Coombe Farm and Stony Lane. Much of the water was emanating from field ditches, together with water rising to the surface along the lower boundary of the solar PV field.

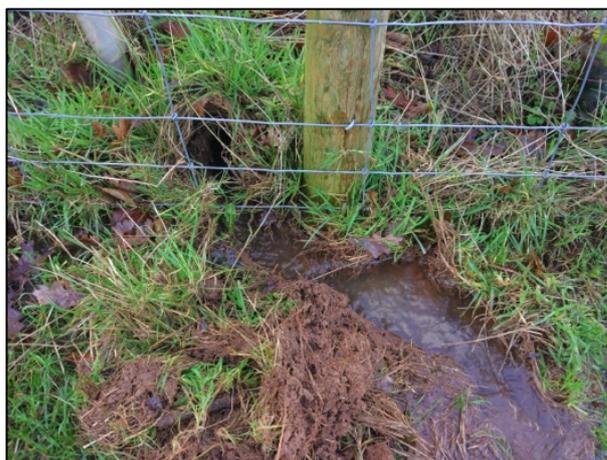
Photo 28 – Upwelling of subsurface flows

Inspection of the area below the solar PV site revealed upwelling of subsurface flows – possibly from the site drainage. There were no obvious signs of overland flows.

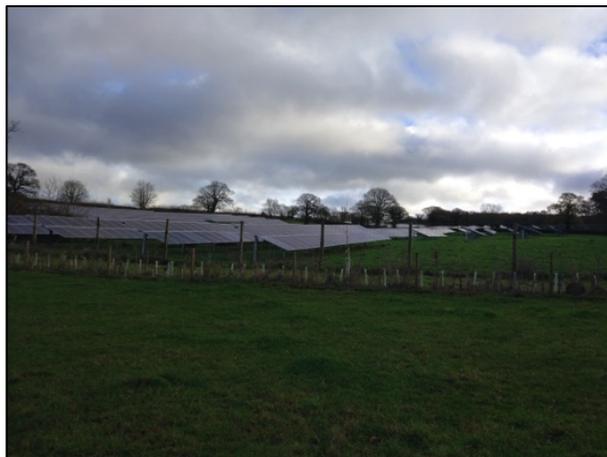
Photo 29 – Newly planted hedges at solar farm

Hedges have been planted along some of the solar farm boundaries. There is evidence from elsewhere that these can improve catchment hydrology by interrupting overland flows and allowing water infiltration to a greater depth. They can also create new habitats.

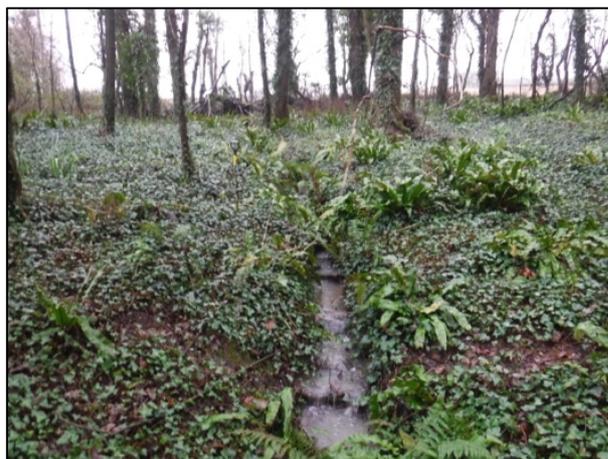
Photo 30 - Drainage through Monday Copse

In this area of woodland (in the middle of the upper catchment) the surface water flow is running straight through a channel in the vegetation. Work could be done to enhance the infiltration of water into the soil and slow the surface water flow.

There may also be potential to increase the area of woodland providing a moderating effect on surface water flows. This could provide other environmental benefits, including carbon sequestration, which may more easily attract funding in the future.

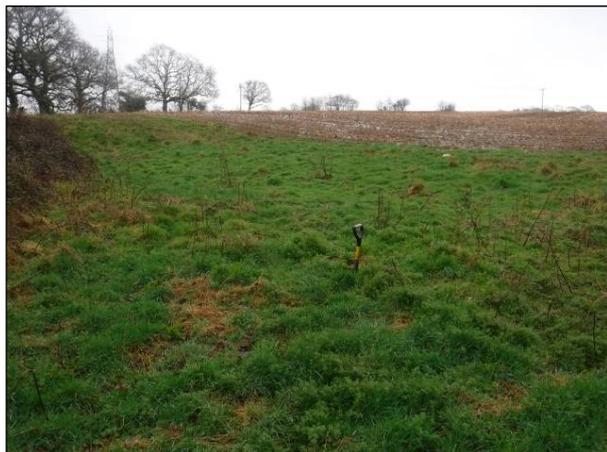
Photo 31 – Strip of rough vegetation at the bottom of a maize field

This shows an existing strip of rough vegetation at the bottom of a maize field. This helps to reduce runoff and also brings other environmental benefits, e.g., improving water quality and increasing habitat diversity.

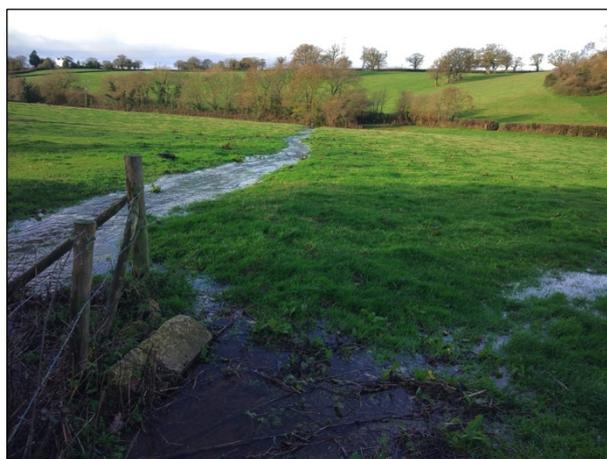
Photo 32 – Example of possible area for swales

This is an area where surface water runoff flows across grassland. The flows could be slowed by increasing storage using swales or banks.

A number of intermittent watercourses were observed crossing grassland as a result of drainage from the surrounding land and highways. There appears to be an opportunity to delay, and reduce, the flow to the Wotton Brook by using physical banks or swales to help to store these flows temporarily. In the flatter sections of the upper catchment there is also the opportunity to reconnect the Wotton Brook with some of its flood plain. This can hold significant quantities of water and slow the flow.

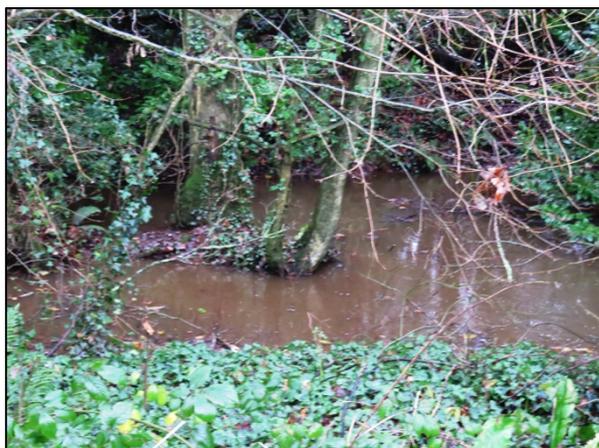
Photo 33 – Naturally formed pond containing highway runoff

This pond has developed naturally in a gully as a result of highway runoff. It allows water to drain slowly. Its effectiveness could potentially be improved by intervention.

The principle of detention ponds is to allow surface water runoff to accumulate in small areas and then drain away at a slower rate to a watercourse. A number of apparently natural areas were observed in the catchment during this study (see Photos 33 and 34). Using excavated areas to store runoff could be a useful method of detaining flows that otherwise would rapidly increase stream flows. In some cases, relatively level roadside ditches could act as temporary storage areas providing they were regularly maintained. This would allow the water to drain away slowly rather than spilling into vulnerable fields or running down the highway as has been observed.

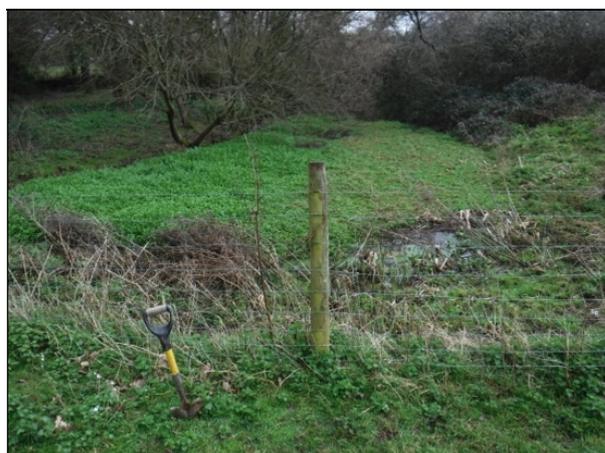
Photo 34 – Example of an existing detention pond

This pond is in an area within the water main drainage network. It is currently full of sediment, which both highlights previous erosion losses and the resulting reduction in capacity to temporarily store surface water runoff. There is an intervention opportunity here which illustrates the potential to create a more effective overall runoff storage system.

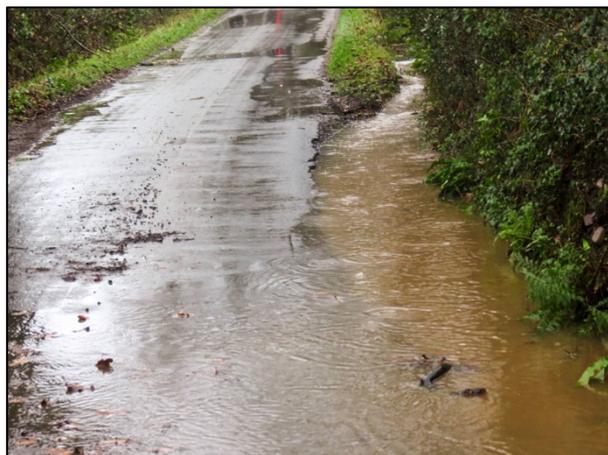
Photo 35 – Example of a highway ditch overflowing

This overflowing on to the highway (and into a field) may be due to lack of ditch maintenance or blocked highway drains. Ditches can provide some storage during intense rainfall events.

- Ensuring highway drainage is operating effectively
- Maintaining ditches for initial storage of runoff
- Ensuring field drainage operates to provide early soil infiltration capacity for subsequent rainfall.

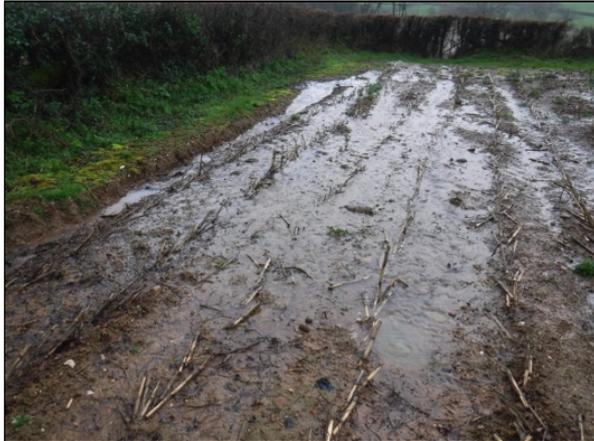
Photo 36 – Blocked field drains causing surface water runoff

In this post-harvest maize field, it appears the field drains have become impeded and the water has been forced back to the surface where it runs over the soil following the down slope towards the nearest drainage channel. Intervention to improve the drainage could reduce the speed of runoff.
